**INTEGRATED ASSESSMENT: PRELIMINARY ASSESSMENT/SITE INSPECTION (PA/SI)
AND REMOVAL SITE EVALUATION REPORT
TCE CLINTON ENGINES SITE
MAQUOKETA, IOWA**

EPA SEMS ID - IAD980317432

**Superfund Technical Assessment and Response Team (START) 5 Contract
Contract No. 68HE0719D0001, Task Order 19F0086, Subtask 004**

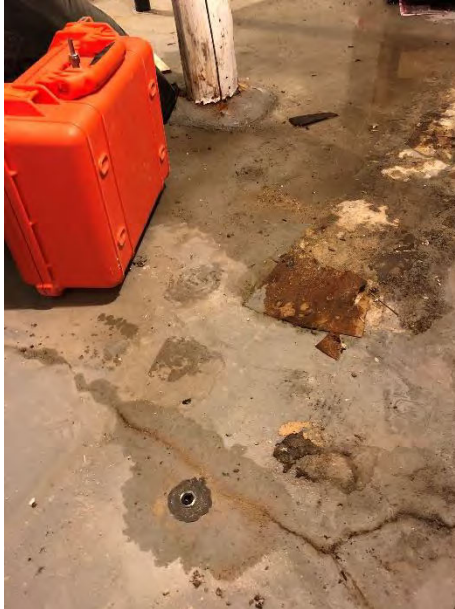
| TETRA TECH PROJECT NO. 103X903019F0086.004 Direction: NA | DESCRIPTION | This photograph shows a typical sub-slab port installation. This port was installed at [REDACTED] S. Matteson St. | 1 |

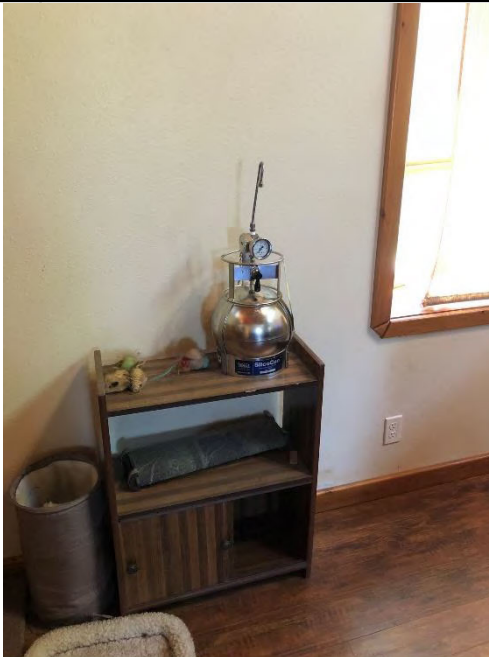
| TETRA TECH PROJECT NO. 103X903019F0086.004 Direction: East | DESCRIPTION | This photograph shows the indoor air sample at [REDACTED] S. Clark St. | 2 |

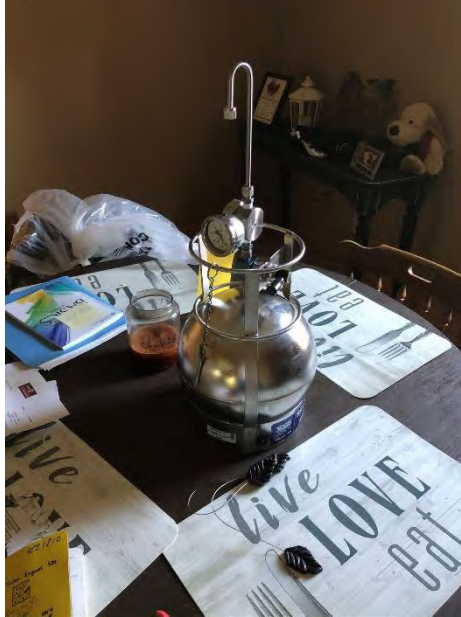
| TETRA TECH PROJECT NO. 103X903019F0086.004 Direction: NA | DESCRIPTION | This photograph shows the indoor air sample at [REDACTED] S. Matteson St. | 3 |

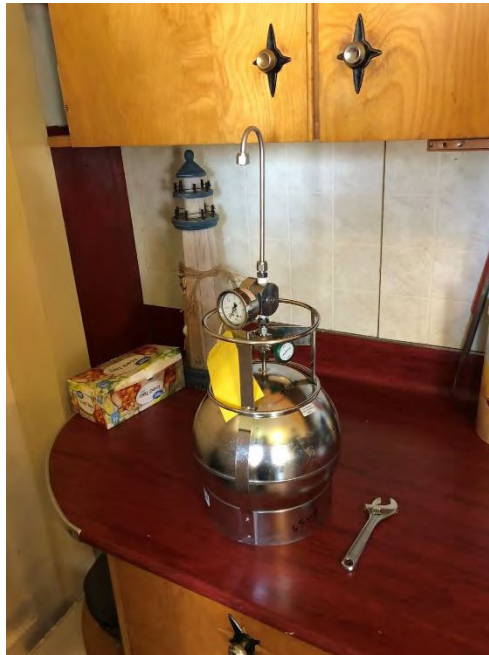
| TETRA TECH PROJECT NO. 103X903019F0086.004 Direction: NA | DESCRIPTION | This photograph shows the indoor air sample at [REDACTED] S. Otto St. | 4 |

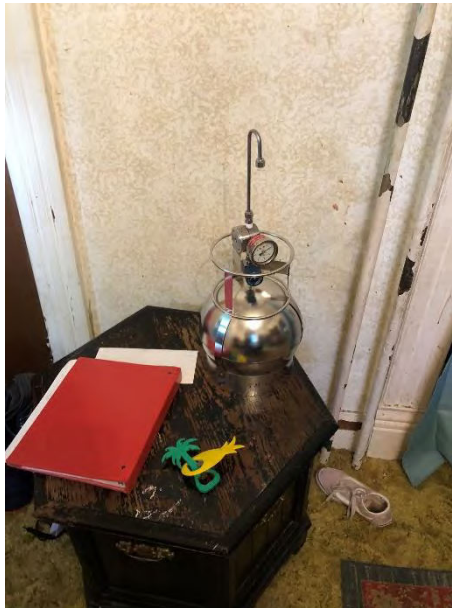
| TETRA TECH PROJECT NO. 103X903019F0086.004 Direction: NA | DESCRIPTION | This photograph shows the indoor air sample at [REDACTED] S. Otto St. | 5 |

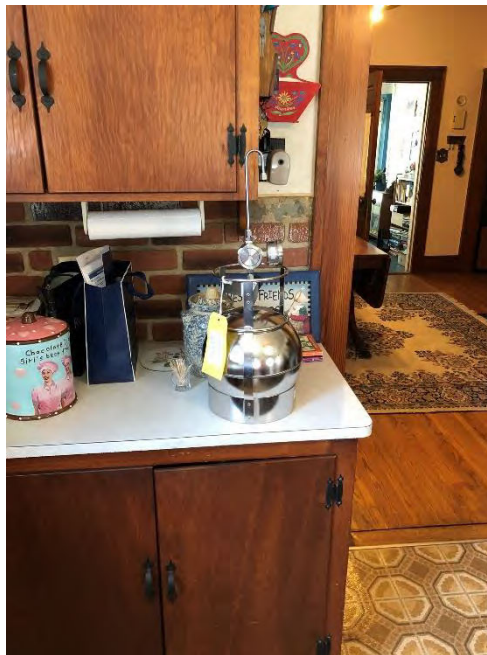
| TETRA TECH PROJECT NO. 103X903019F0086.004 Direction: NA | DESCRIPTION | This photograph shows the indoor air sample at [REDACTED] S. Matteson St. | 6 |

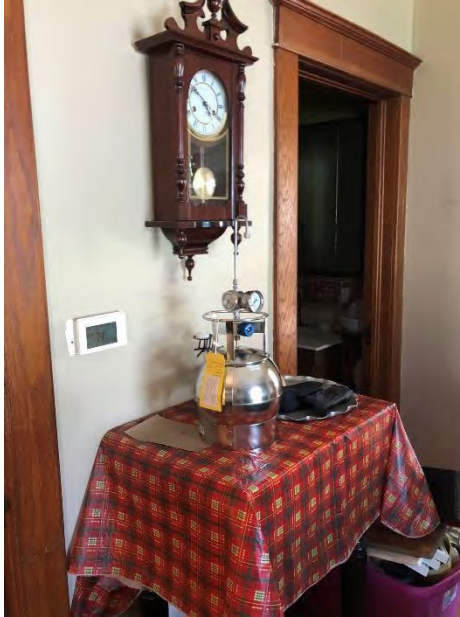
| TETRA TECH PROJECT NO. 103X903019F0086.004 Direction: NA | DESCRIPTION | This photograph shows the indoor air sample at [REDACTED] S. Matteson St. | 7 |

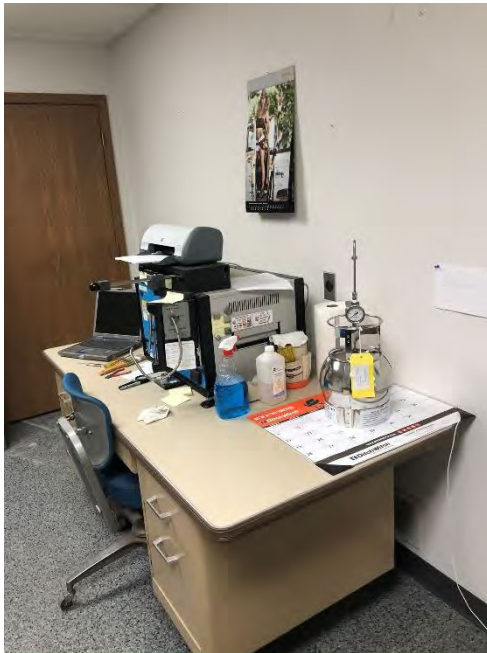
| TETRA TECH PROJECT NO. 103X903019F0086.004 Direction: NA | DESCRIPTION | This photograph shows the indoor air sample at [REDACTED] Maple St. | 8 |

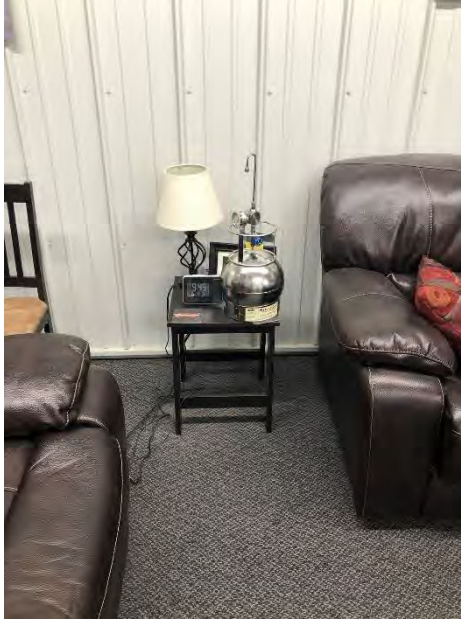
| TETRA TECH PROJECT NO. 103X903019F0086.004 Direction: NA | DESCRIPTION | This photograph shows the indoor air sample at [REDACTED] E. Maple St. | 9 |

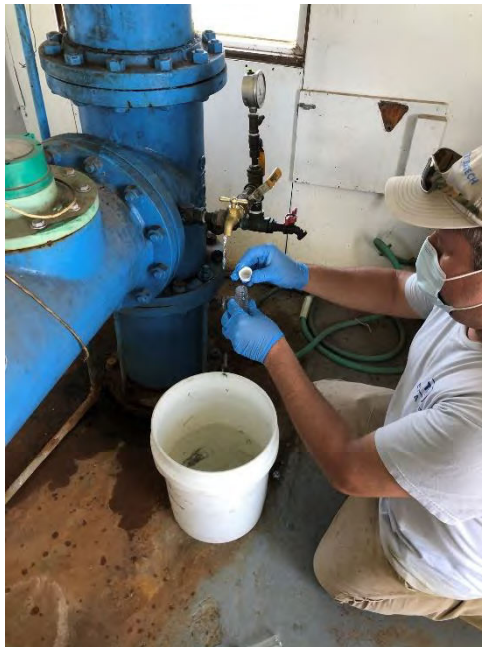
| TETRA TECH PROJECT NO. 103X903019F0086.004 Direction: West | DESCRIPTION | This photograph shows collection of sample from City Well #4. | 10 |

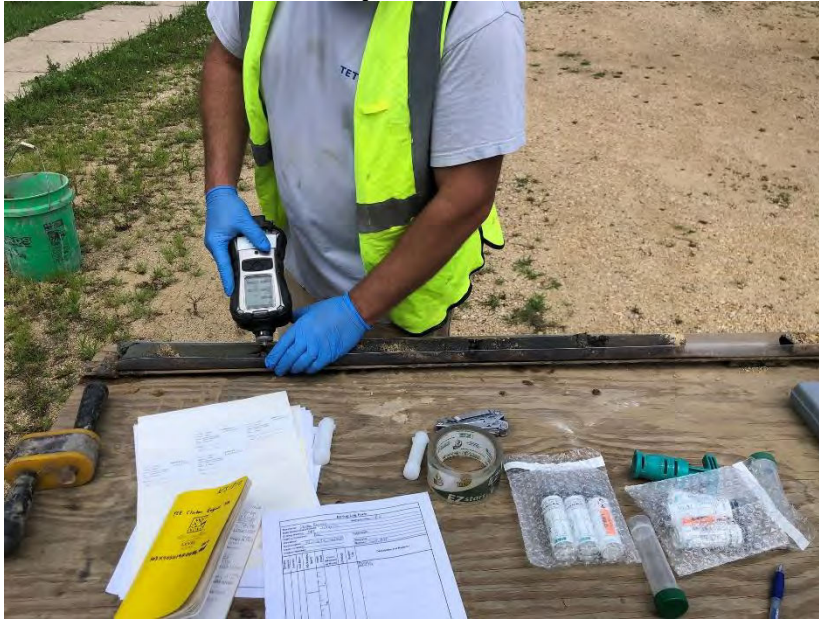
| TETRA TECH PROJECT NO. 103X903019F0086.004 Direction: North | DESCRIPTION | This photograph shows the Superfund Technical Assessment and Response Team (START) screening the soil core from SB-6. | 11 |

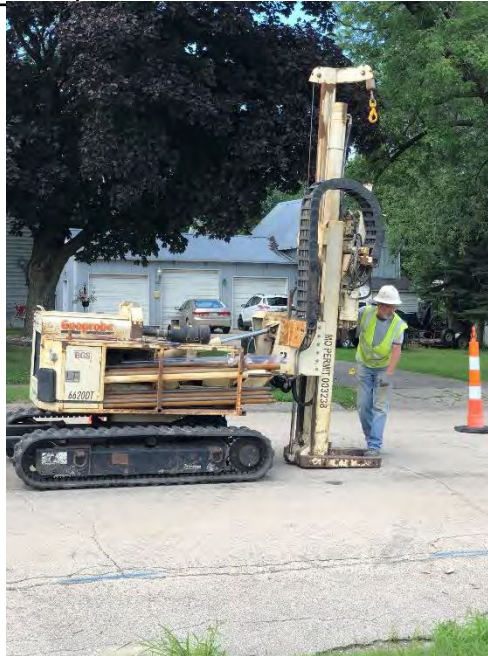
| TETRA TECH PROJECT NO. 103X903019F0086.004 Direction: West | DESCRIPTION | This photograph shows direct-push technology (DPT) operations at location SB-6. | 12 |

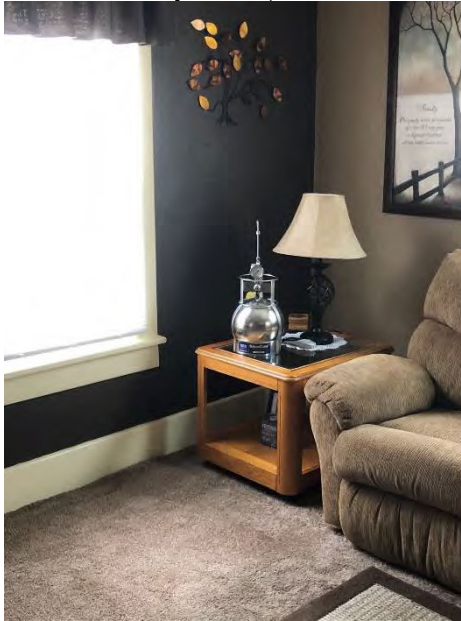
| TETRA TECH PROJECT NO. 103X903019F0086.004 Direction: NA | DESCRIPTION | This photograph shows the indoor air sample at [REDACTED] E. Platt St. | 13 |

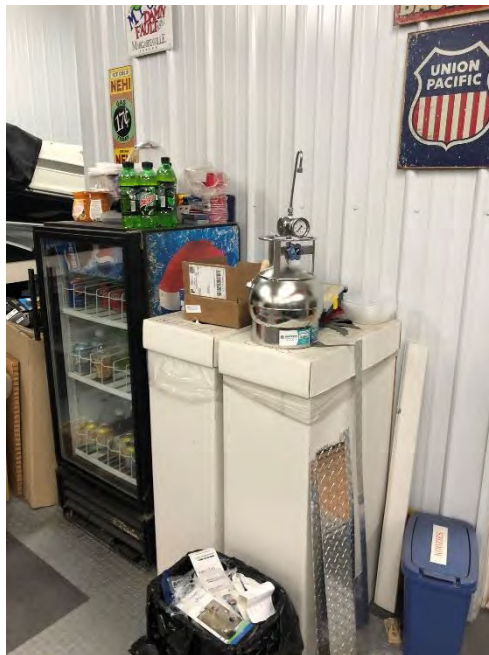
| TETRA TECH PROJECT NO. 103X903019F0086.004 Direction: NA | DESCRIPTION | This photograph shows the indoor air sample at [REDACTED] E. Maple St. | 14 |

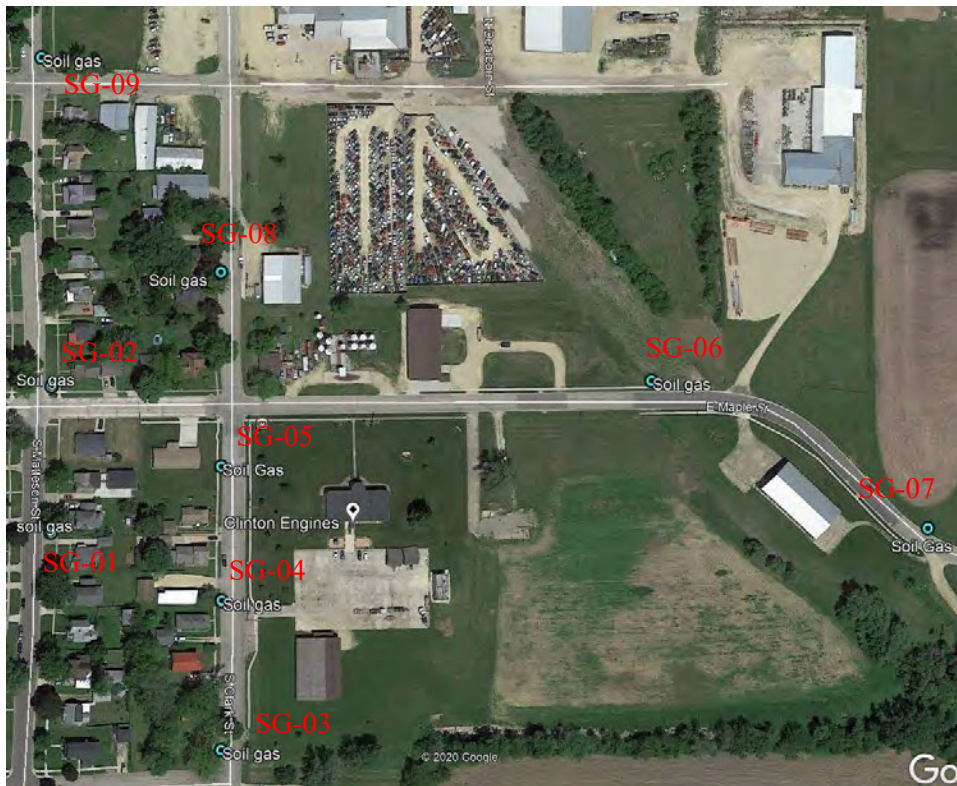
Figure 2: Soil-Gas sampling locations. Nine of 12 locations, three additional locations located north.
